**UNITED STATES ENVIRONMENTAL PROTECTION AGENCY  
Facility Inspection Program  
701 Mapes Road  
Fort Meade, Maryland 20755-5350  
(410)-305-3029**

Re: U.S. Coast Guard  
2401 Hawkins Point Road  
Baltimore, MD 21226

**RESOURCE CONSERVATION RECOVERY ACT SUBTITLE-C INSPECTION**

Inspection Date: March 30-31, 2011

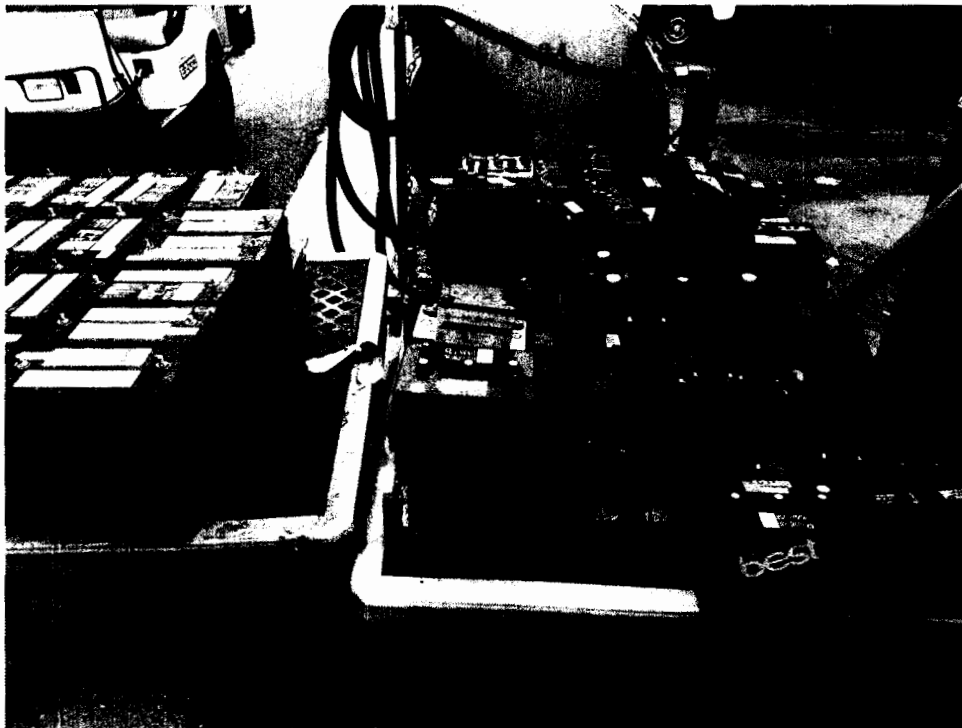
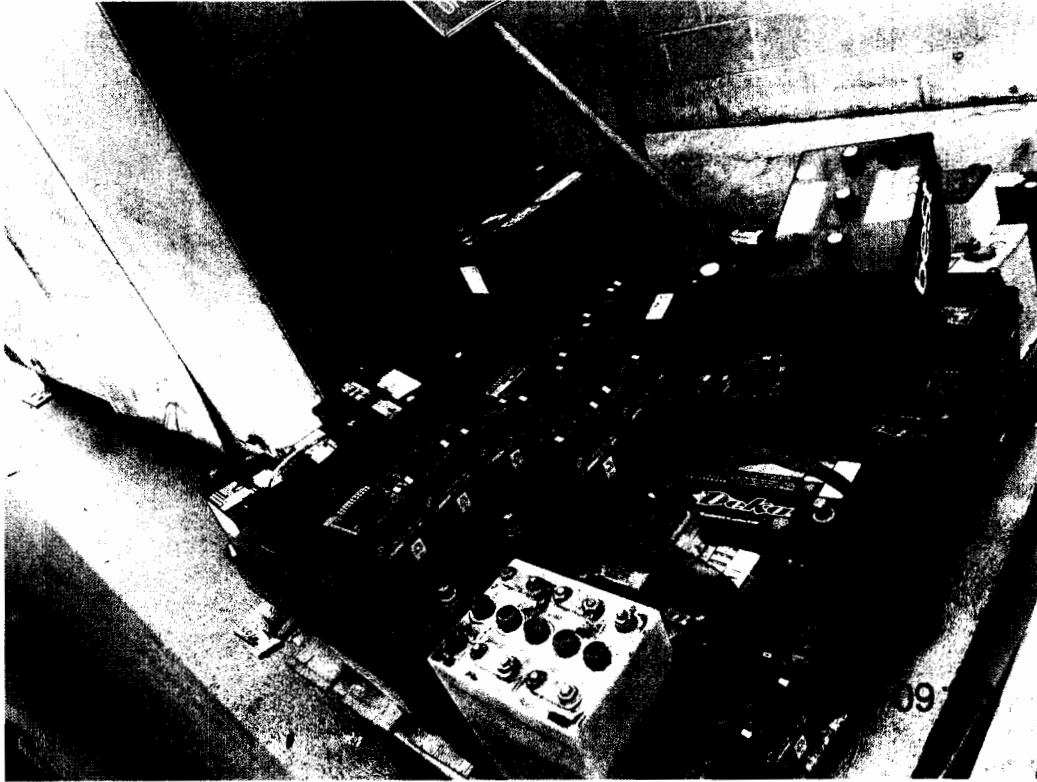
**Photo 36: Lead/acid battery storage area**

- The pallets of paint related material and batteries had a single label for each pallets and not on each container.
- The Facility was storing lead acid batteries outside of building 66. None of the batteries stored in this area had a waste label and start accumulation date.

The Facility was storing there waste lead acid batteries outside next to building 66. The Facility employees either bring the batteries over directly or contact Ms. Wisniewski to come and pick up the batteries. At the time of the inspection there were two full pallets of lead acid batteries. The Facility stated they have an agreement with an outside company to pick up the batteries for recycling. The garage supervisor, Mr. Bob Kline is in charge of calling for a battery pickup. There were no start accumulation dates or universal waste labels on any of the batteries (**See Photos #36 - #38**).

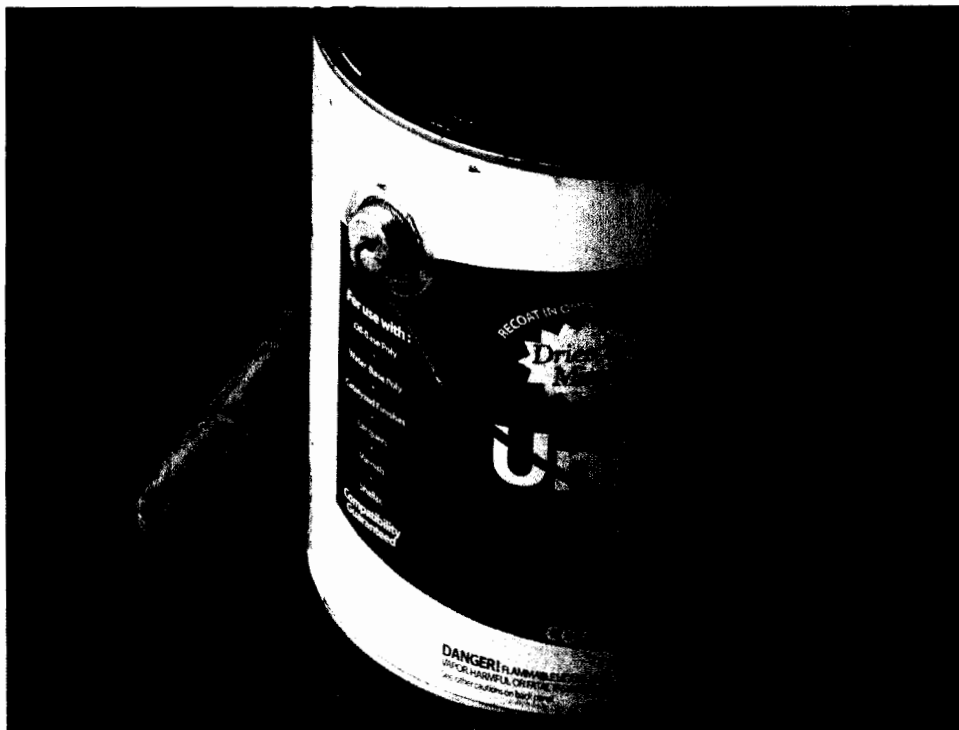
**Photo 35: Flammable finisher can in MAA with no label or date**

- In the less than 90 day storage (building 151) there was a 1 gallon container of finisher with no hazardous waste label and start accumulation date. There was a warning on the finisher label that stated the product was flammable.

This building is the main accumulation area (MAA) for the Facility's hazardous waste before disposal. There were 17 drums of waste, 2 cardboard boxes of used mercury lamps, 1 red plastic container of hazardous waste gas, 1 can of finisher, 3 pallets of batteries, and 2 pallets of waste paint related material (**See Photos #28 - #33**). At the time of the inspection the oldest start accumulation date on the containers was 1/5/2011 (**See Photo #34**). The waste batteries and paint related material had a single hazardous and or universal waste label for each pallet. The finisher did not have any type of hazardous waste label or associated start accumulation date. The original label warned the material is flammable (**See Photo #35**).

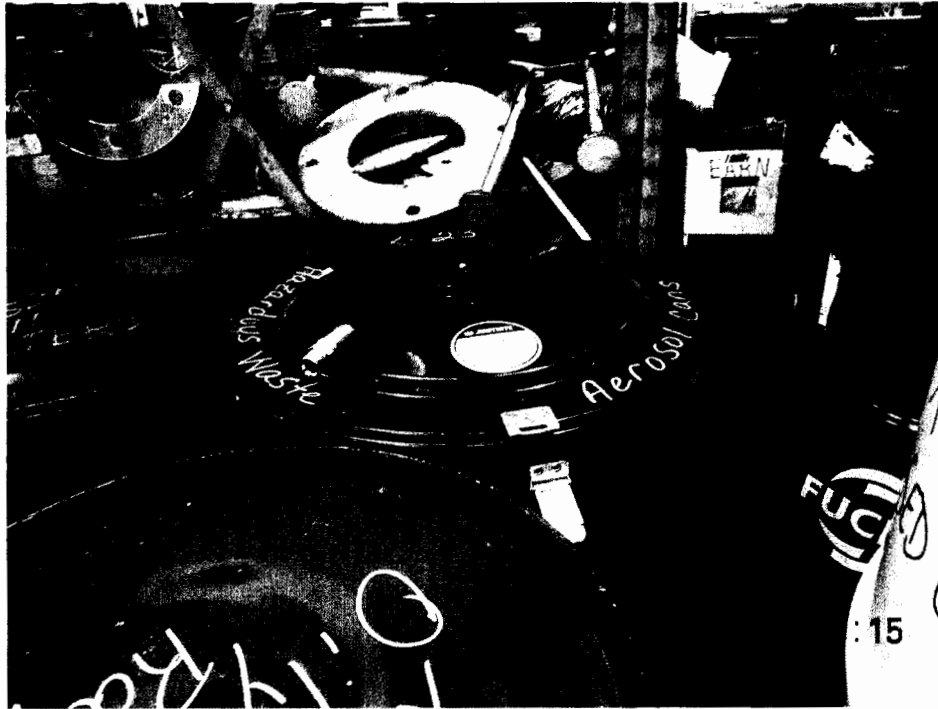
Photo 26: Building 58 aerosol SAA

The activity within this building includes maintenance machine work. There is a 55 gallon hazardous waste drum for waste aerosol cans (**See Photo #26**). The drum was labeled and closed. The drum was observed to be ½ full.

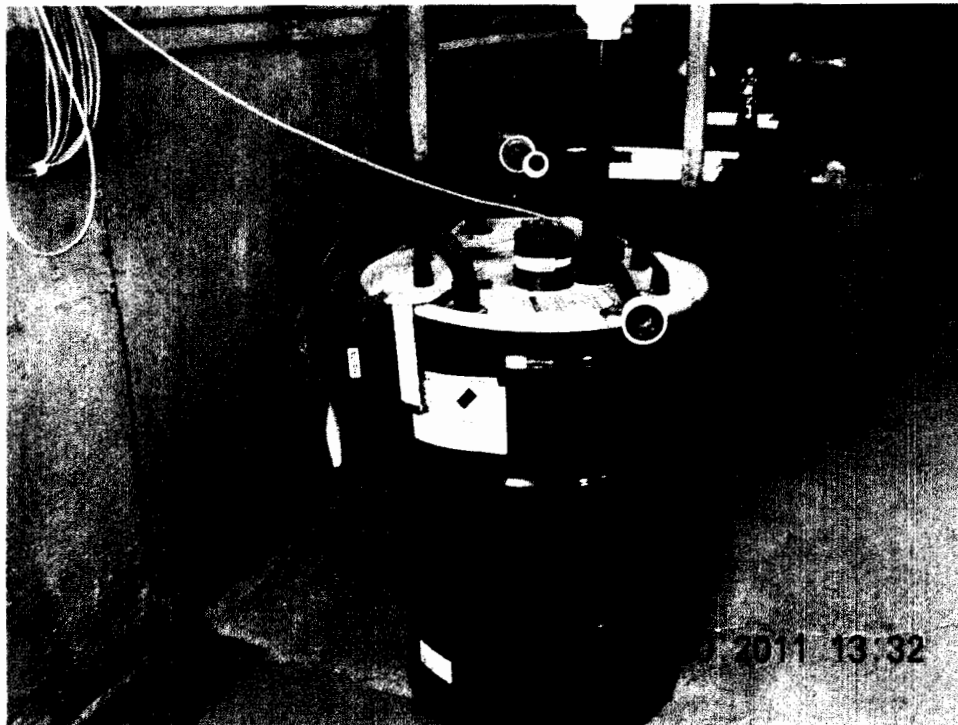
Photo 27: KIRA bulb/lamp crusher

- The contractor KIRA has a bulb crusher in their building. The drum attached to the crusher machine has a label of universal waste. The filter media, once no longer viable is put into the drum with the crushed bulbs.

This building is run by an onsite third party contractor (KIRA). According to the Facility the contractor just recently started on March 16, 2011. The EPA inspector met with project manager, Mr. Buck Buchanan. KIRA does some basic maintenance work at the Facility, including the service and repair associated with the lighting. Within the building there is a lamp/bulb crusher (**See Photo #27**). The process for disposing of lamps was a contact for each building would call KIRA and they would come replace the lights. The lamp crusher sits atop a 55 gallon drum. The drum has a universal waste

label with a start accumulation date of 3/29/2011. The EPA inspector asked what is done with the HEPA filter once it is changed out. KIRA stated they put the filter inside the drum and send everything out as universal waste.

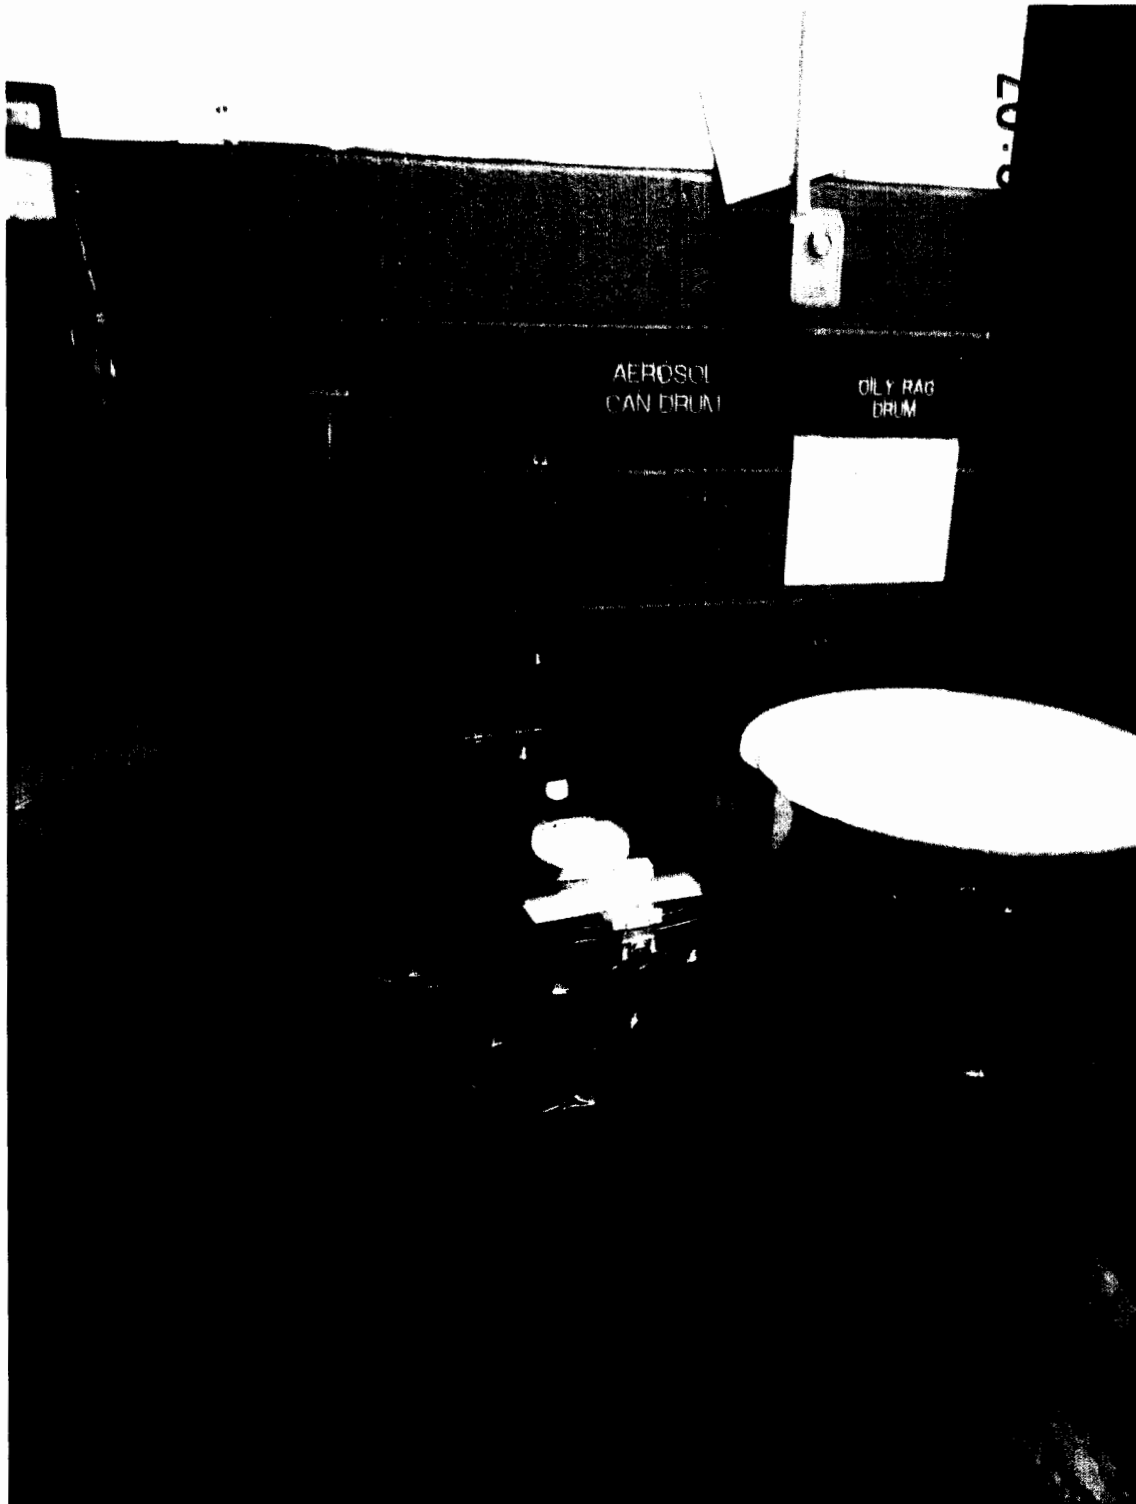
Photo 25: Building 8 aerosol SAA

- In the pipe shop (building 8) the Facility had a SAA with a 55 gallon for hazardous waste aerosol cans. There was no hazardous waste label or markings to denote the contents of the drum. Along with the aerosol cans being generated in building 8, building 8A, which is separated from building 8 by a door, brings over their waste aerosol cans and puts them into the SAA in building 8. The hazardous waste aerosol cans generated in building 8A are not under control or near the point of generation for the waste stream.

This building conducts maintenance work in support of the Coast Guard vessels. Within the building the Facility has a 55 gallon hazardous waste aerosol drum (**See Photo #25**). The EPA inspector asked where the aerosol cans were being generated. The Facility stated they generate the aerosol cans in building 8A and bring the waste cans through a doorway and into building 8. The 55 gallon drum did not say hazardous waste or have any labels denoting the contents. There was a label on the wall that stated aerosol can drum. Once the EPA inspector conveyed this concern, the Facility put a label on the drum.

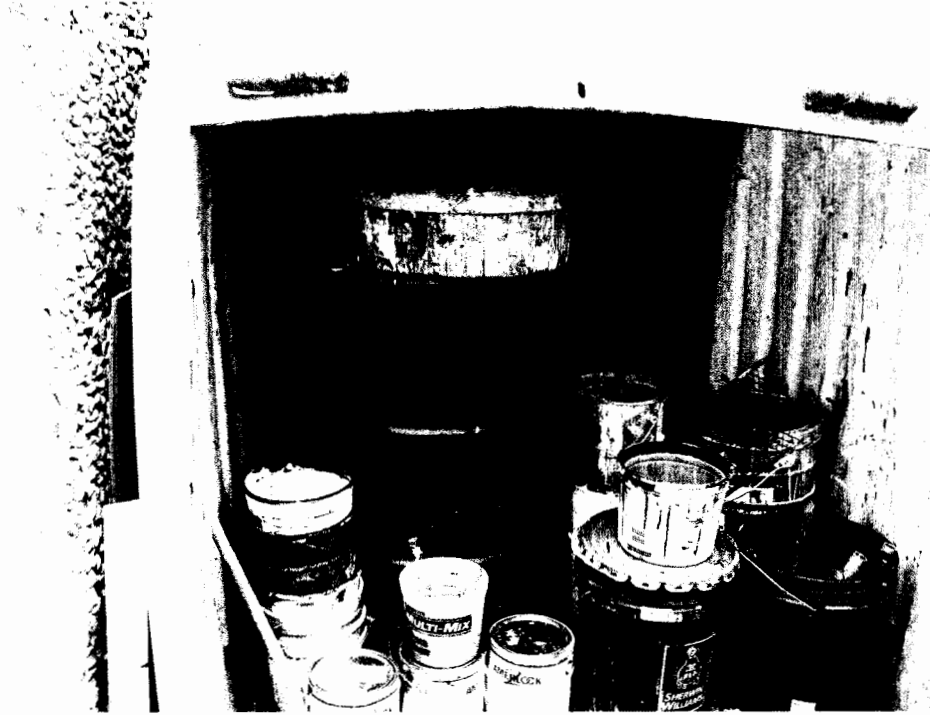
Photo 23: Oakridge Dry Dock SAA

- At the Oakridge dry dock area, the Facility has a SAA with a 55 gallon hazardous waste drum, which collected hazardous waste from pier 1, pier 2, and Oakridge area. The drum did not have a hazardous waste label or markings denoting the contents of the drum. There was no start accumulation date on the drum. The drum was collecting waste from multiple areas and processes. The Facility was

treating this area as an SAA and not a less than 90 day area. No weekly inspections were being conducted for this drum.

The main activity in this area is the maintenance and repair being conducted on the vessels from pier 1, 2 and Oakridge dry-docks. The SAA has a 55 gallon dry located in a PIG containment unit (**See Photo #23**). The drum was closed but there were no labels denoting hazardous waste or the contents of the drum. The Facility stated this drum is being treated as a hazardous waste drum. Waste being collected in this drum is from multiple generation points from pier 1, 2, and Oakridge dry-docks. There is no start accumulation date on the drum.

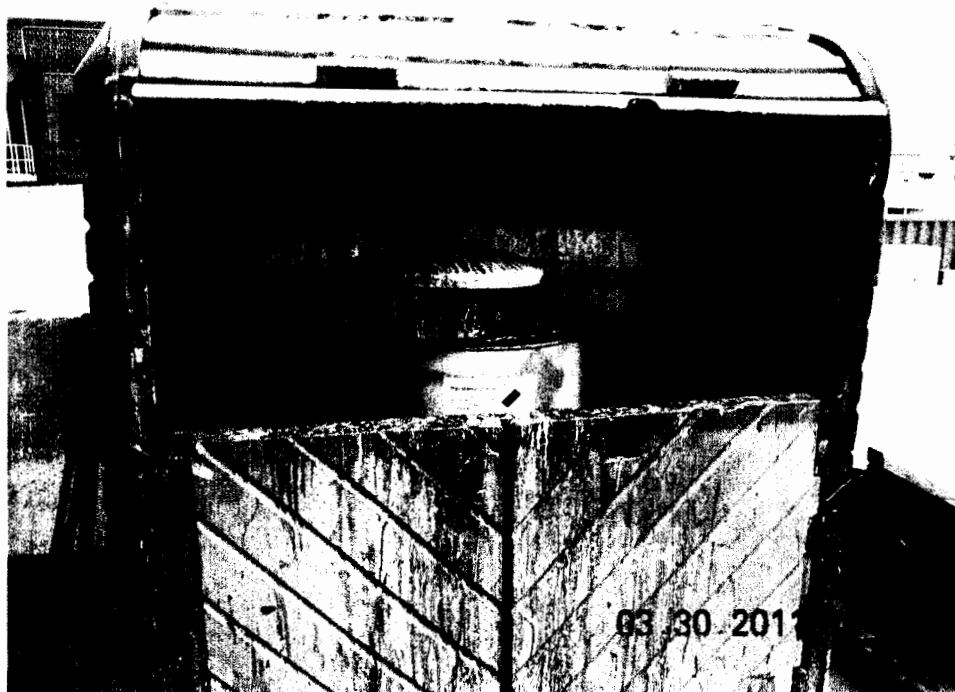
**Photo 22: Shiplift SAA**

- At the ship lift area the Facility had a SAA with a 55 gallon hazardous waste drum. There was a funnel on the drum, but the funnel was just sitting on top the open bung of the drum. The drum was not closed.

The main activity is the dry docking of Coast Guard vessels for repair and maintenance. The EPA inspector met with paint supervisor Mr. Larry Phinney. There is a SAA in a PIG containment unit. The SAA houses a tan 55 gallon hazardous waste drum (**See Photo #22**). There is a funnel on top the drum sitting in an open bung.

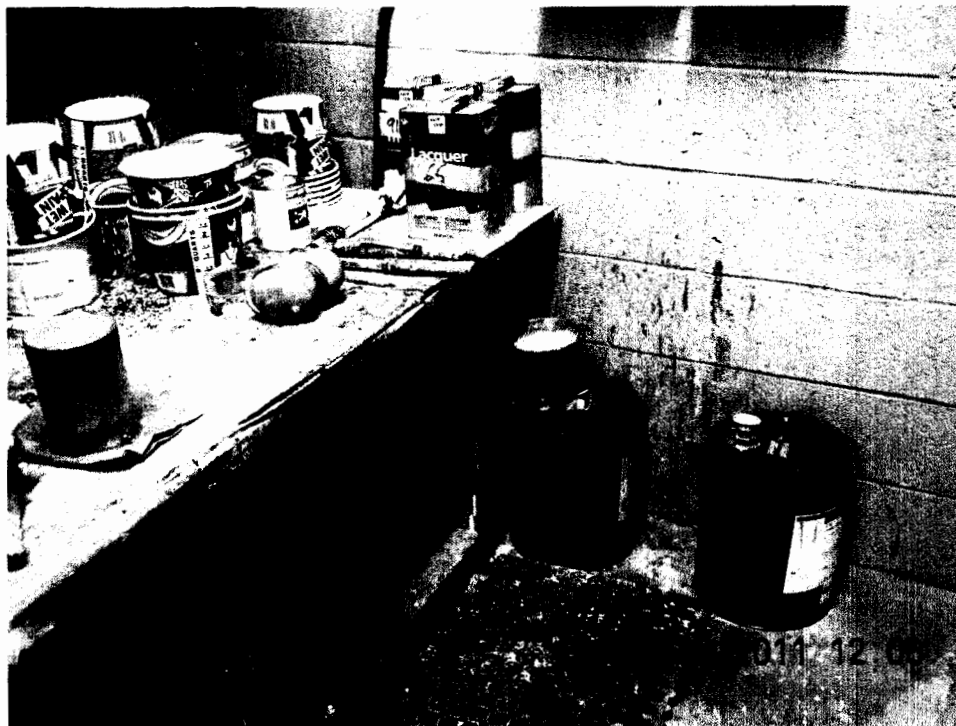
Photo 20: Building 40A waste-like thinner containers outside main electronic paint shop

- Near the paint shop in the electronics shop, there was a container of thinner, which had a funnel and appeared to be used to collect waste. There were no hazardous waste labels or markings denoting the contents.

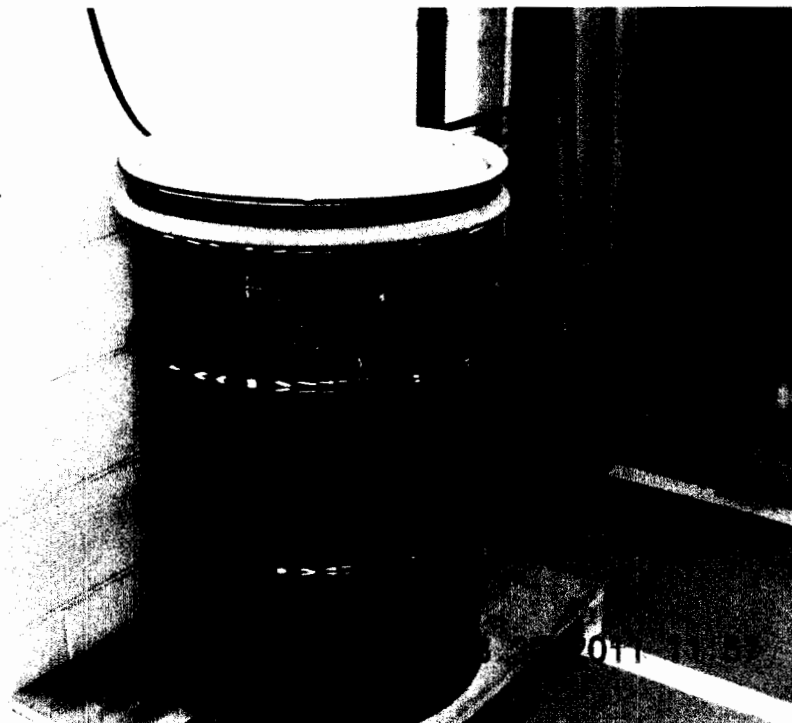
**Photo 18: Building 40A incorrect hazardous waste designation**

- Also in the electronic shop there was a drum that said hazardous waste oily rags. The drum was almost full. The Facility stated this is non hazardous.

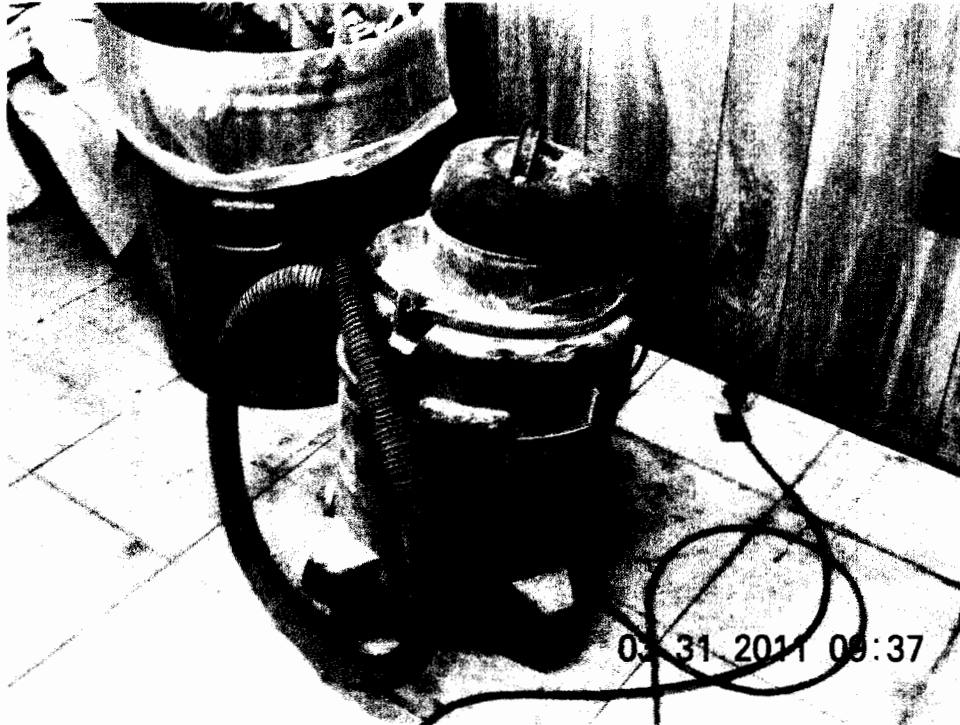
Photo 15: Building 5 trailer vacuum

- The Facility is using a vacuum to clean up in the trailer, and when the vacuum is full it is being dumped into the SAA. The Vacuum could possibly be another SAA in the trailer.

The main activity within this building is engine maintenance and repair. The EPA inspector met with shop planner, Mr. Gary Ludwig. The Facility has an SAA located next to a paint booth. Within the SAA is a 20 gallon drum of waste aerosol cans and a 30 gallon drum of waste paint slop (**See Photo #10**). The aerosol cans are collected from throughout the building and the waste paint slop is from painting operations in the paint booth. This building also has 5 part cleaning washers that were stated to be handled by Safety Kleen Inc. The Facility has a 5,000 gallon caustic cleaning tank that is used to clean engines. Once the caustic solution is no longer viable, the Facility stated the waste is sent out as hazardous waste. The Facility uses a third party contractor (Clean Venture) to come and clean the tank. Located in a trailer next to building 5 are two grit blasting machines. This area is used by the employees in building 5 to clean and blast miscellaneous engine parts. According to Mr. Ludwig, there are two filter plates that catch the waste blasting grit/powder. These units are connected to the outside of the trailer. The filter plates are emptied by employees 2 times a month, into a pale and brought back into the trailer, where the waste grit/powder is stored in a black 55 gallon hazardous waste drum. This area is designated as a SAA (**See Photo #11**). The EPA inspector observed what appeared to be waste grit/powder piled up on the blacktop below the filter plate (**See Photo #12**). This blacktop slopes towards the water (Arundel Cove). The EPA inspector also observed what appeared to be a fine grit/powder layer covering the cabinets, machines, and furniture inside the trailer near the 55 gallon SAA drum (**See Photo #13 & #14**). The Facility also stated they use a vacuum to clean up the trailer (**See Photo #15**). Once the vacuum is full, it is emptied into the 55 gallon SAA.

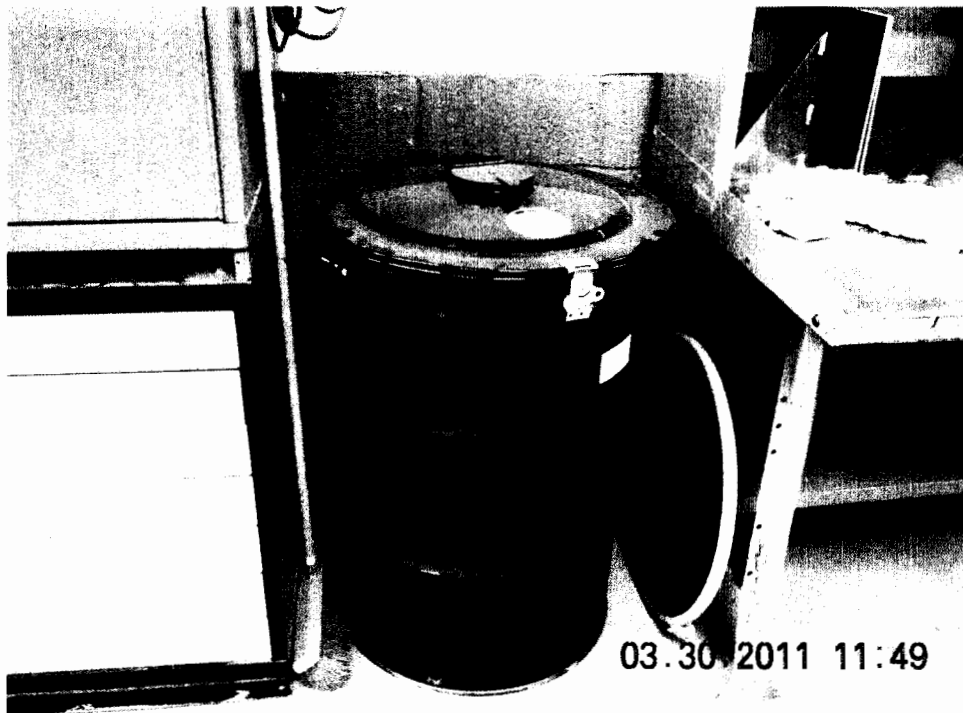
Photo 16: Building 40A small paint shop SAA no label

- In the electronic shop (building 40A) there was a SAA with a 55 gallon hazardous waste drum of aerosol cans. The drum was about ½ full and there were no hazardous waste labels or markings denoting the contents of the drum.

The main activity associated with this building is the rebuilding and installation of electronic systems on the vessels. EPA inspector met with electronic shop foreman Mr. Brian Ames. Within the front of the electronic shop the Facility has a small paint booth. Mr. Ames stated they only use paint cans to spray paint. The Facility had a black 55 gallon drum they were using to collect the waste aerosol paint cans. The cans were stated to be treated as hazardous waste but the drum did not have any type of markings denoting hazardous waste or the contents of the drum (**See Photo #16**). The EPA inspector observed the drum was ½ full. Once the Mr. Young relayed his concerns, the Facility labeled the drum detailing the contents as hazardous waste aerosol cans (**See Photo #17**). There was a black 55 gallon drum that stated hazardous waste oily rags (**See Photo #18**). Ms. Wisniewski stated this was an incorrect designation of the drum. The drum was not hazardous waste. The oily rags throughout the rest of the Facility were being treated as non hazardous waste. Located near a large main paint booth in the electronic shop was a grit blasting machine (Snap-On) (**See Photo #19**). The blasting grit is vacuumed up and put into a 55 gallon drum. The EPA inspector asked if the Facility had made a determination on the waste. The Facility stated they have analysis for the waste. The Facility then stated this machine has only been in use for a few months and they have not shipped out waste from this unit. Located outside of the paint booth was a container of thinner that had a funnel and appeared to be waste-like (**See Photo #20**). The EPA inspector asked who was in charge of the area and the Facility stated the painter Mike Rockocy. Mr. Rockocy was not present during the inspection. Outside of the building was a SAA for the paint slop from the paint booth. The drum was in a PIG containment unit, along with another drum that was labeled used oil (**See Photo #21**). The paint slop drum was empty at the time of the inspection.

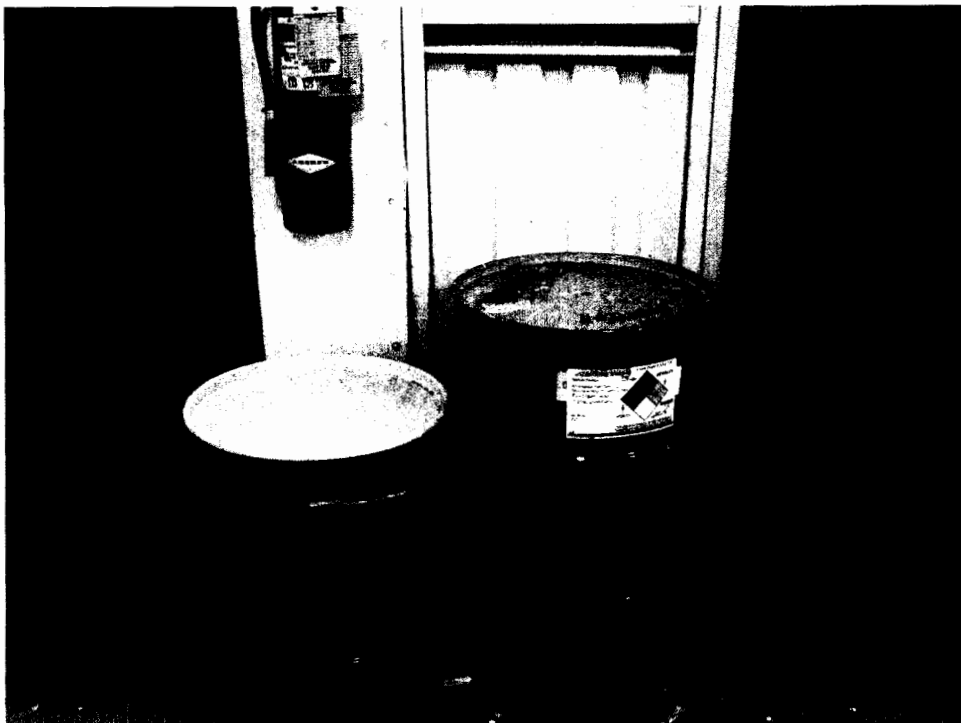
**Photo 10: Building 5 SAA**

- In the engine repair and maintenance (building 5) shop, the Facility had a 30 gallon hazardous waste slop drum in their SAA that was stated to be full and ready to move. There was no start accumulation date on the drum. The Facility later put a start accumulation date on the drum during the inspection.

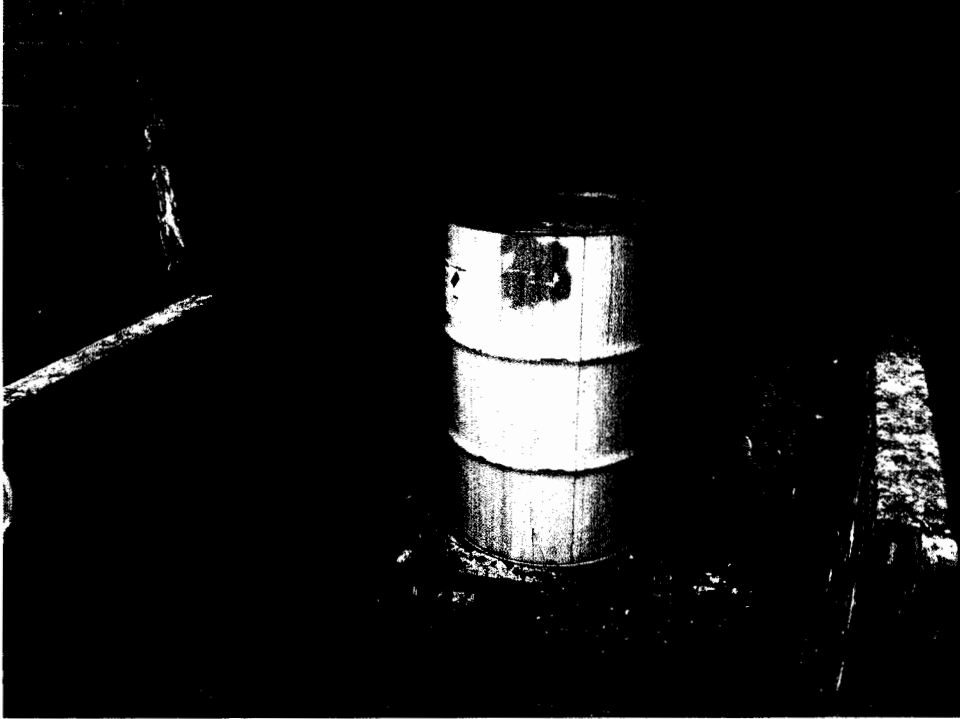
**Photo 7: Building 32/90 SAA**

- At the main paint shop (building 32 and 90), there is a SAA for multiple paint booths outside the building. The waste generated from the paint booths is carried outside to the SAA. The SAA is messy with lots of paint splatter.

This area of the Facility housed the majority of the painting operations. The EPA inspector met with the general foreman for painting, Mr. Leon Wilson. The majority of the painting being done was on buoys, and miscellaneous prefabrication parts for the vessels (**See Photo #6**). Once the painting operations were finished, left over slop and thinner was brought out to a SAA for hazardous waste paint slop. This SAA is located outside of building 32. This SAA accumulates hazardous waste from painting operations inside of building 32 and building 90. The SAA housed a 55 gallon drum inside of a PIG containment unit (**See Photo #7**). The drum was closed and labeled. There was paint splattered all over the drum and containment unit. Located right next to the SAA for building 32, were 3 other hazardous waste drums of paint slop (**See Photo #8 & #9**). The EPA inspector asked the Facility where these drums originated. The Facility stated the area beside the SAA for building 32 is considered a staging area, where hazardous waste paint slop drums from other SAA's located at the Facility are stored prior to being sent to the less than 90 storage area. At the time of the inspection the 3 drums of hazardous waste paint slop had labels and were closed, but none of them had start accumulation dates.

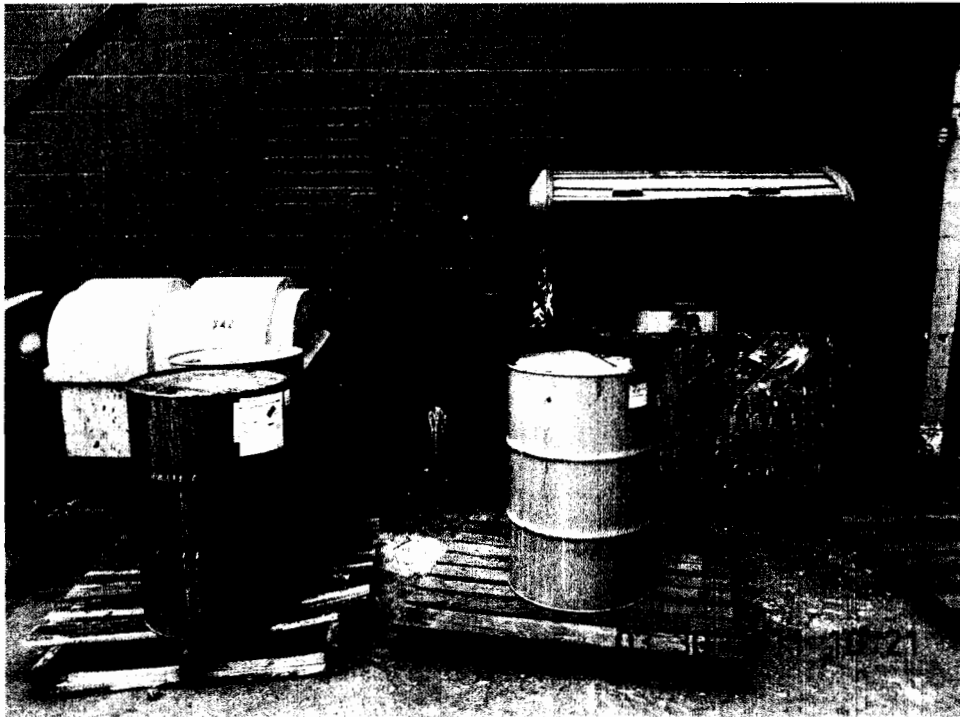
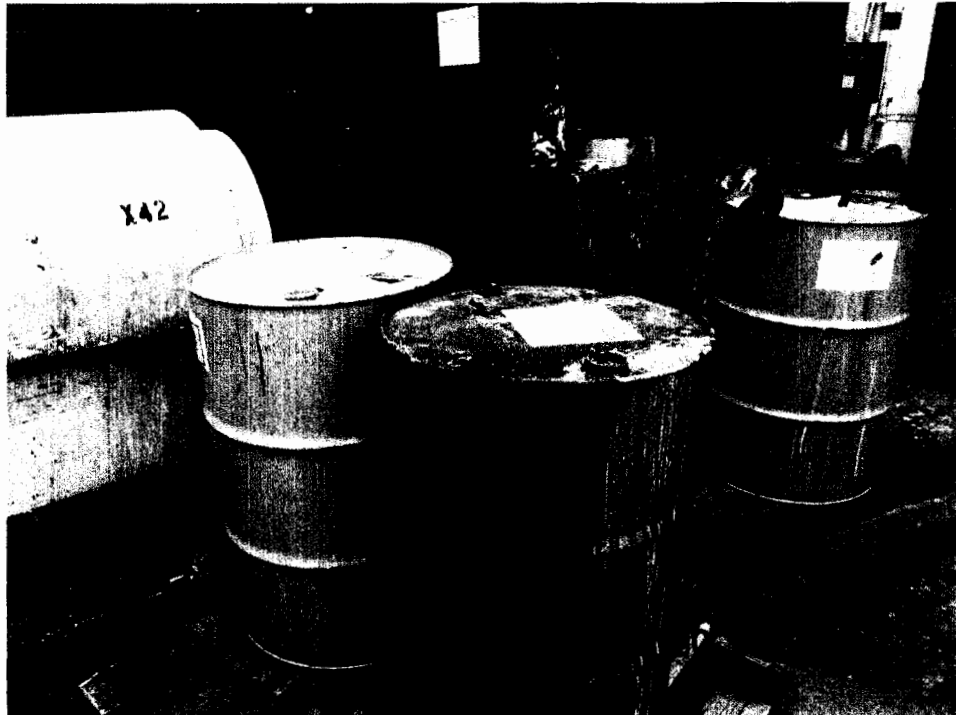
**Photo 8: Building 32/90 drum staging area**

- There were 3-55 gallon hazardous waste drums located next to the SAA at the main paint shop. The Facility stated this is a staging area for the other SAA's before being sent over to the less than 90 storage (building 151). There were no start accumulation dates on these drums.

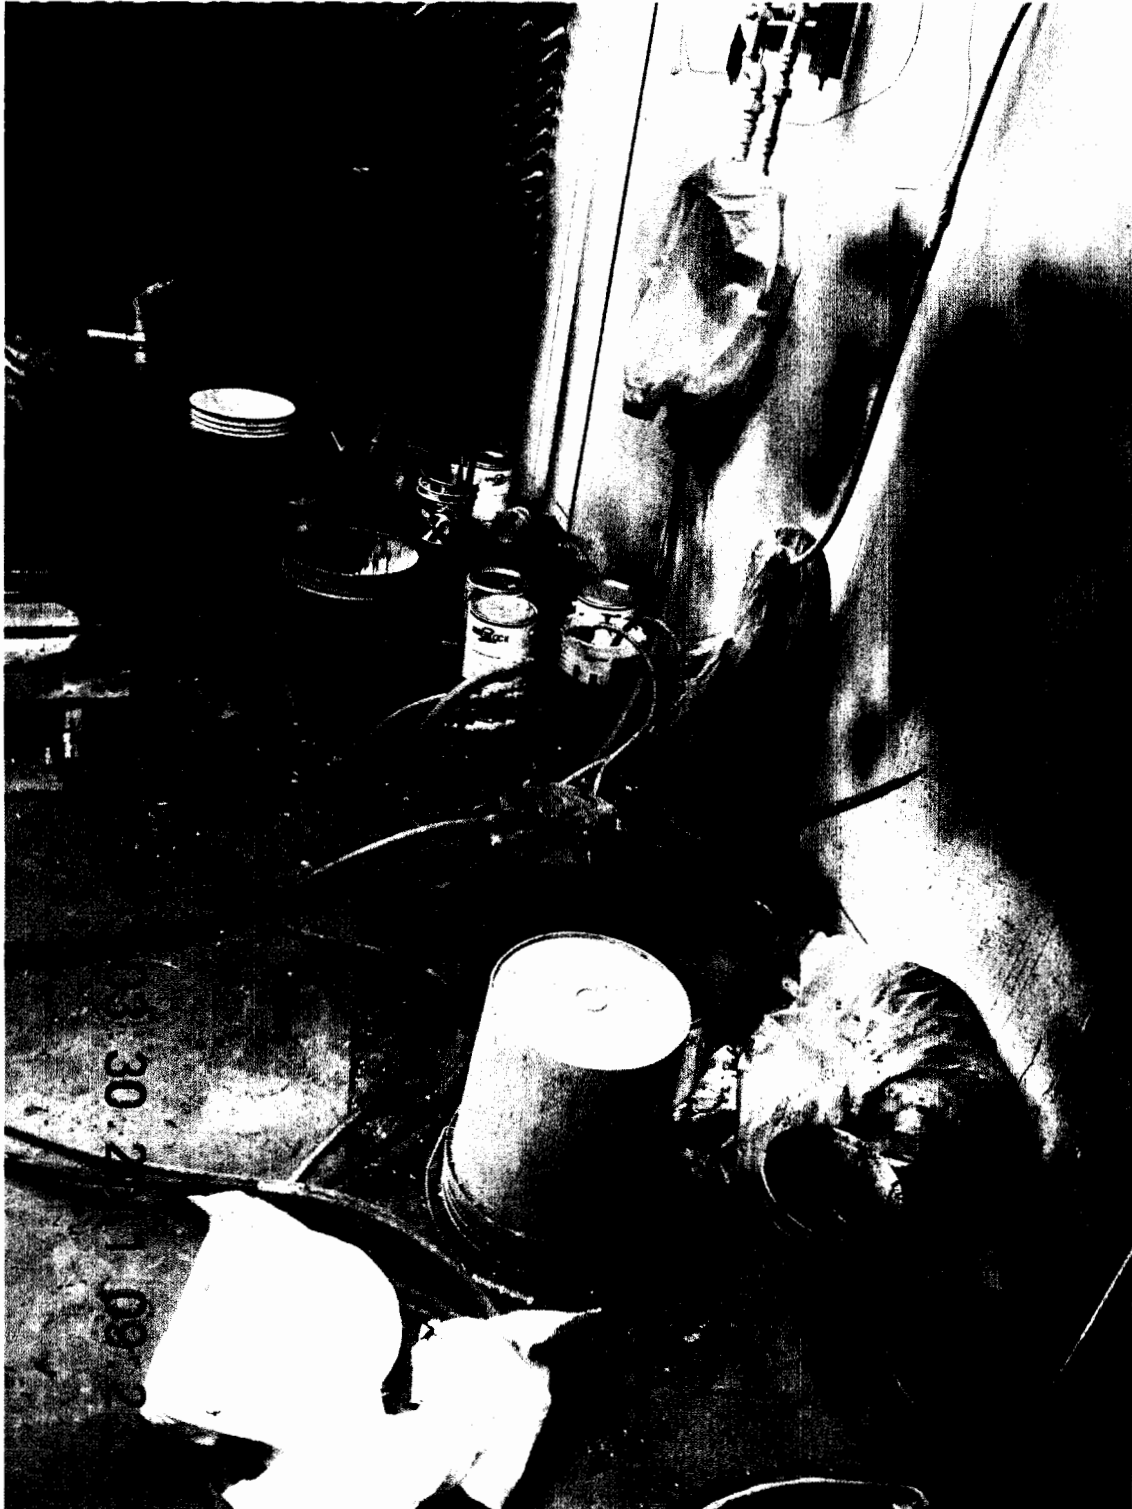
Photo 4: Building 11 paint booth

- Waste from the paint booth, that was stated to be carried out to the SAA on a daily basis was still sitting in the paint booth from the prior days work.

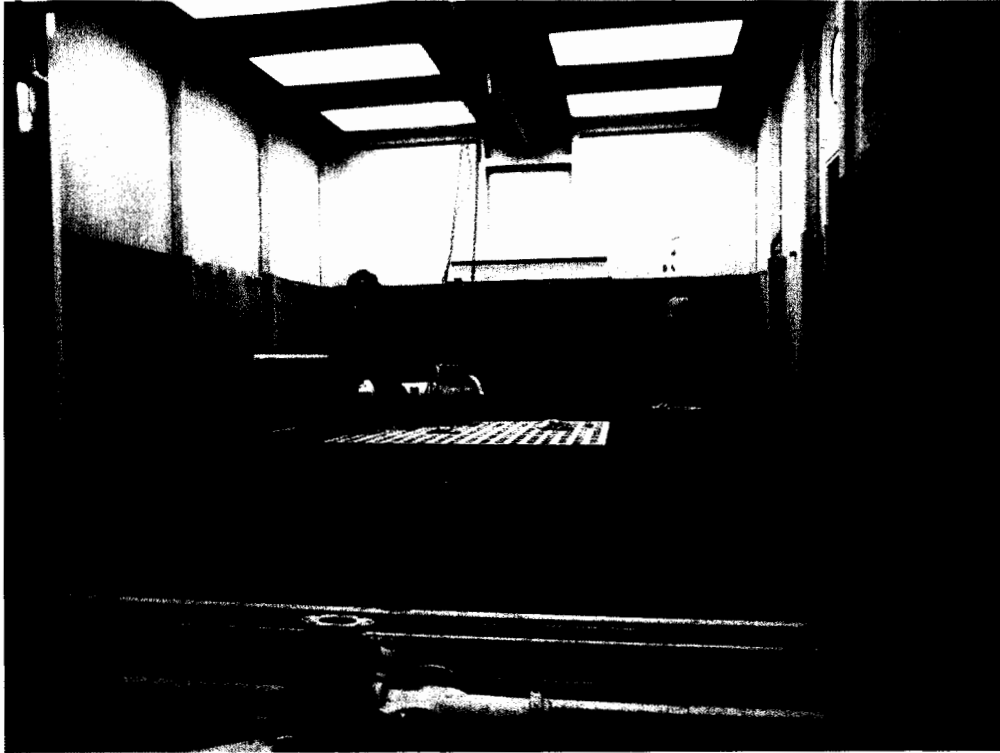
**Photo 2: Building 11 blasting booth**

- The inside machine shop (building 11) has a grit blasting booth connected to a 55 gallon drum of waste outside the building. This waste was stated to be sent out as hazardous waste. This area would be considered a SAA, but the drum did not say hazardous waste or detail the contents.
- The inside machine shop (building 11) has a paint booth. The waste generated inside the booth gets carried out to a SAA outside the building. The SAA is not

under control of the operator or at or near the point of generation for the waste stream. The SAA is splattered with old paint residue.

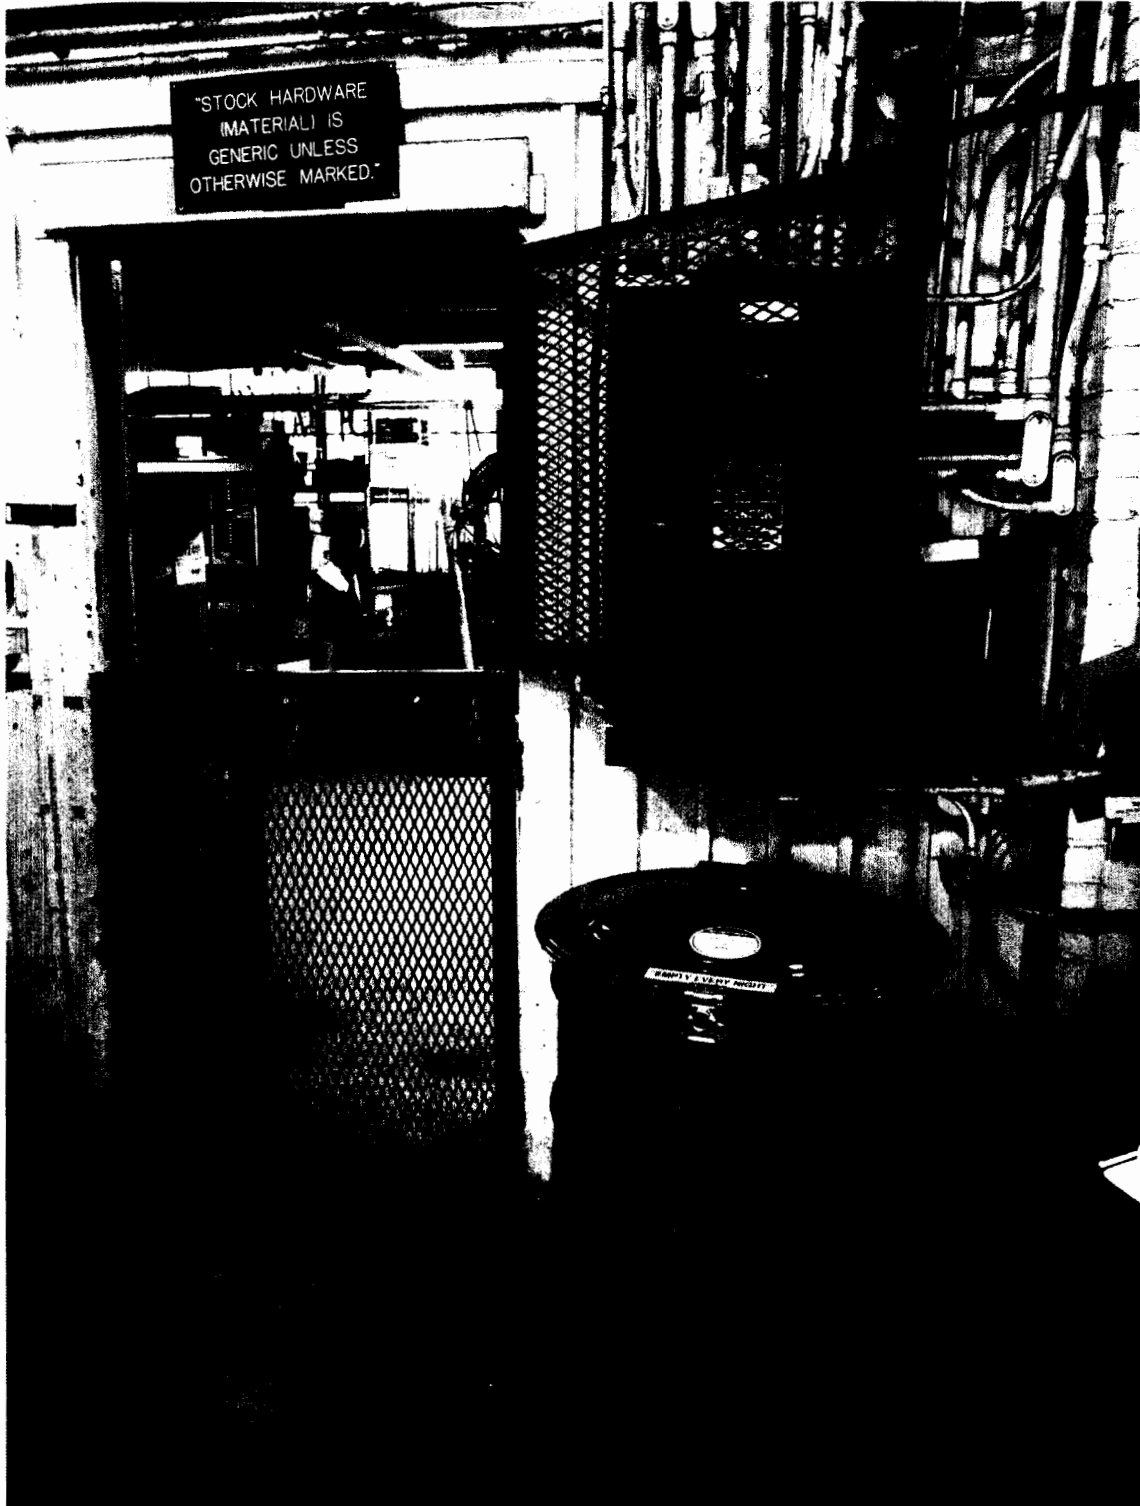
Photo 1: Building 11 aerosol SAA

The main activity within this building is the maintenance and repair of vessel engines. The shop foreman for the building is Mr. Bob Byrd. The shop houses a 55 gallon hazardous waste SAA (**See Photo #1**). This SAA accumulates waste aerosol cans that are used throughout the shop. The drum is located next to the stock maintenance room. The drum was labeled with the words hazardous waste aerosol and had a closed lid. The EPA inspector viewed inside the drum, which was 2/3 full. Also located in this building is blasting booth (**See Photo #2**) and paint booth. The EPA inspector spoke with painter Mr. Mike Anderson. The blasting booth has a vented air system, which collects the fine blasting grit and deposits it into a 55 gallon drum located outside of the building. In conversations with the Facility, this waste stream is considered to be hazardous based on analysis. At the time of the inspection this collection drum did not have any hazardous waste label or contents (**See Photo #3**). The Facility was not treating this drum as a SAA for hazardous waste. Within the paint booth, there were multiple containers of liquid and semi-liquid contents (**See Photo #4**). Mr. Anderson stated this was waste that at the end of the day be carried outside to a hazardous waste SAA slop drum. The Facility has a SAA for slop waste from painting operations in the paint booth. This SAA is located outside of the building in a PIG containment unit (**See Photo #5**). The EPA inspector asked when the waste in the paint booth was generated and Mr. Anderson stated the waste was from the prior days activities and had been sitting in the paint booth overnight. There were no hazardous waste labels or contents marked on the containers in the paint booth. The SAA for the slop paint was closed with a label. The
